TECHNICAL REPORT

NO. 12776

WINTER TESTING OF VEHICLE
EXHAUST DUST EJECTION SYSTEM, RUBBER
TIRE HUBS, AND PERSONNEL HEATER SYSTEM
ON THE M60 A3 TANK

JUNE 1982

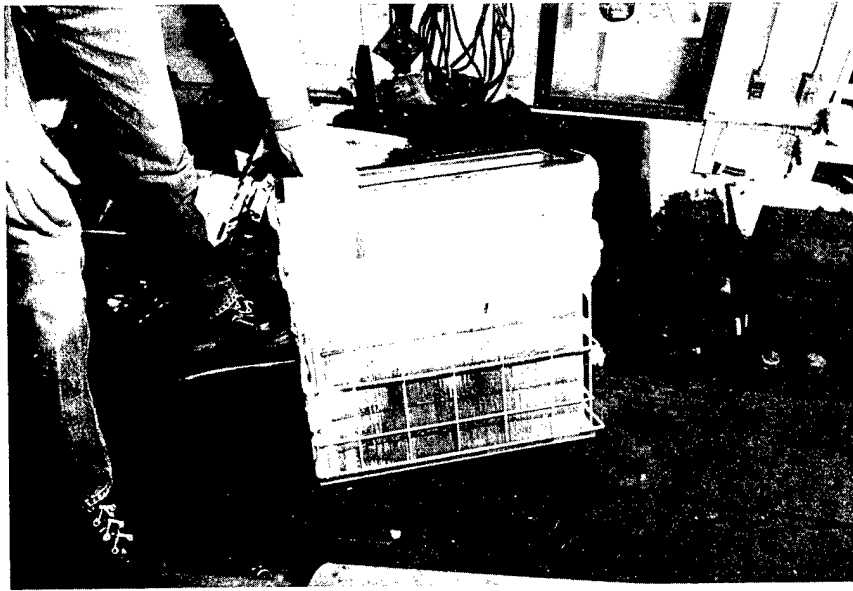
1. A heavy layer of snow had accumulated on the VEDES filter element. The snow covered approximately 75% of the filter media on both sides of the filter element. Figure 2 shows the filter element covered with snow.

Figure 2. VEDES filter element after 50 miles of operation in powder snow.

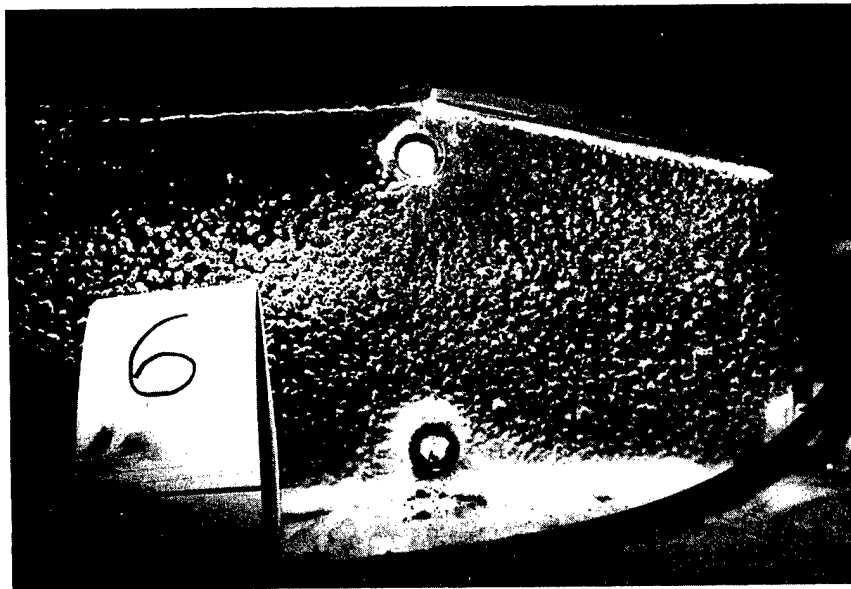
2. Snow had accumulated in the pre-cleaner and had reached the top of the scavenge cleanout plug. See Figure 3.
3. Restriction on the VEDES filter element had reached 20 inches of water. See Figure 4.
4. The VEDES check valve was found to be frozen shut as a result of water accumulation and freezing in the scavenge tube.
5. A layer of snow covering approximately 25% of the ACBM filter element was found. See Figures 5 and 6.
6. Restriction on the ACBM filter element had reached 4.8 inches of water.
7. There was no accumulation of snow in the pre-cleaner compartment of the ACBM system.

Figure 3. Snow accumulation in the pre-cleaner after 50 miles of operation in powder snow reached the top of the scavenge cleanout plug.

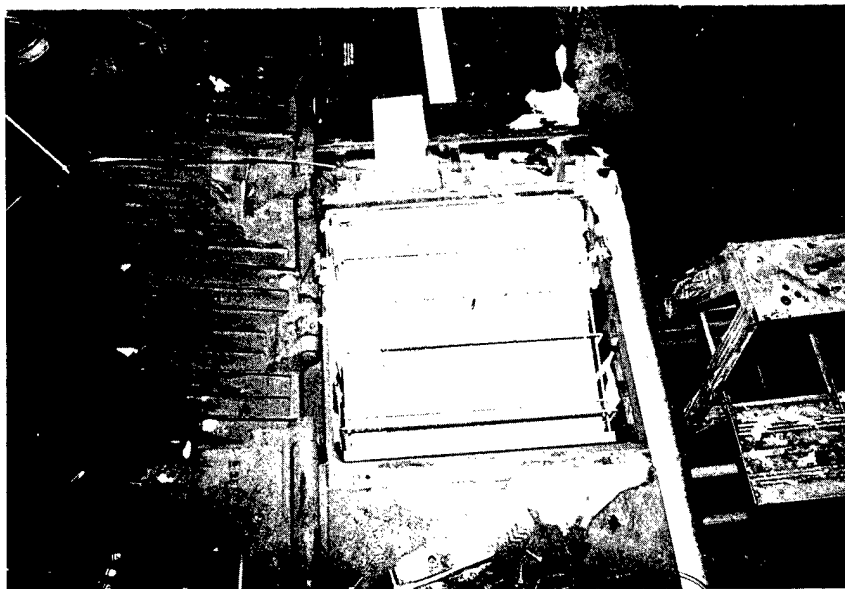
Figure 5. ACBM filter element after 50 miles of operation in powder snow.

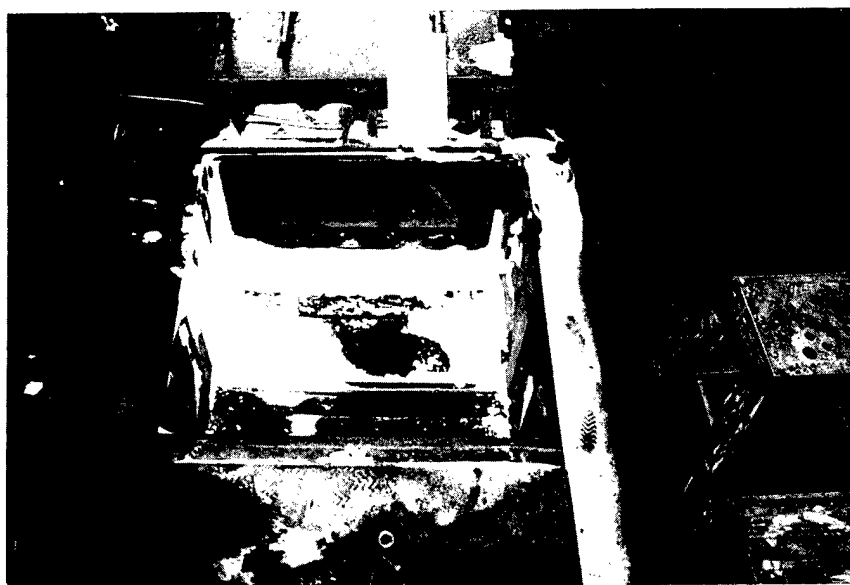
Figure 6. ACBM filter compartment after 50 miles of operation in powder snow.

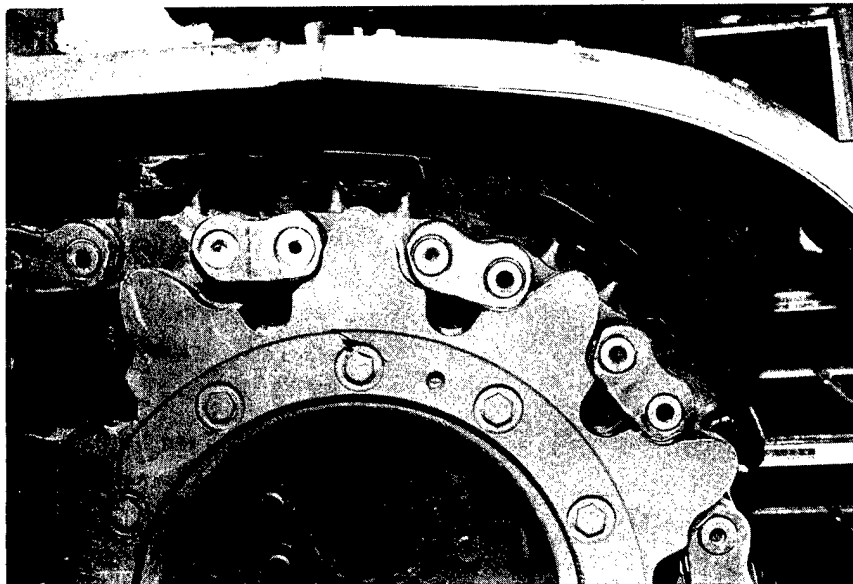
it was noted that there was a mismatch between the RTH sprockets and the track end connectors. This mismatch caused wear to the sprocket teeth and end connectors as seen in Appendix A. Appendix A shows wear to three selected end connectors on both sides of the track as well as the wear to the RTH sprockets.

One set of tracks was worn out after 250 miles of operation. The track was replaced with a spare, and end connector and sprocket wear were recorded. Figure 12 shows the excessive wear between the sprocket teeth and end connectors after 250 miles.

Figure 12. Track and sprocket misalignment and excessive end connector wear (250 miles).

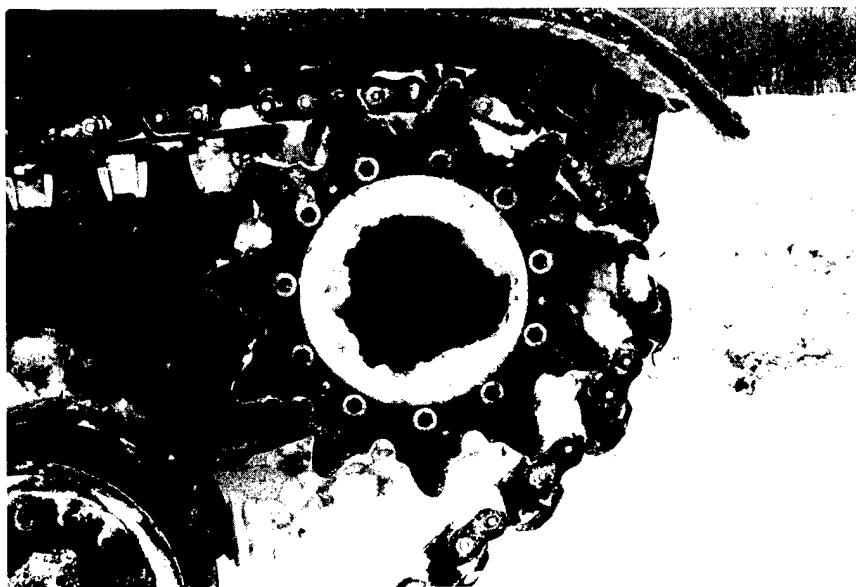
Snow was definitely a problem for the rubber tire hubs. The hubs would pack with snow and cause the track to jump over the drive sprocket teeth. The driver had to be careful not to jump the track.

Figure 13 shows the track climbing over the top of the sprocket teeth. Figures 14 and 15 show the snow build-up between the RTH and the track causing the track to lift up and misalign. Figure 16 shows the test vehicle operating in a typical snow environment.

Figure 13. Snow build-up between the track and sprocket caused the track to climb over the sprocket teeth.

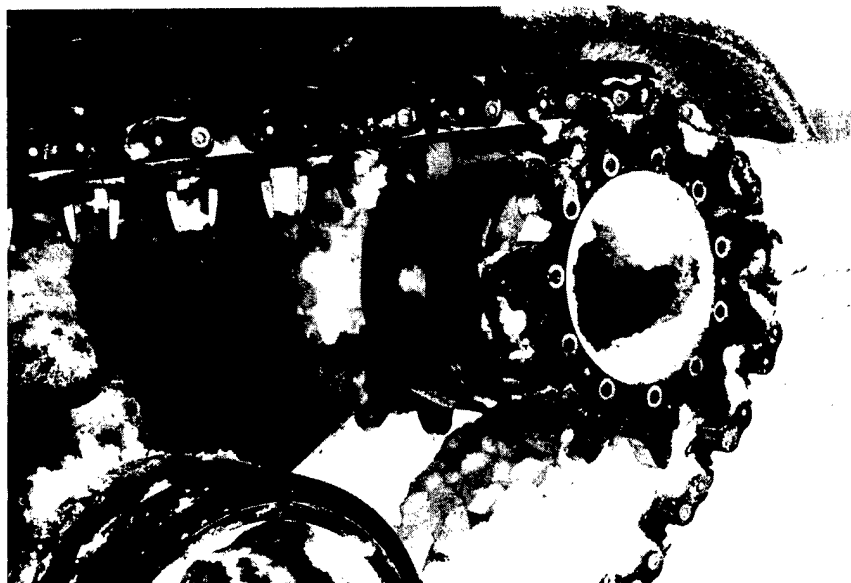
Figure 15. Snow build-up between the track and sprocket.
